SAINT JOHN RIVER BASIN
Limestone, Maine

LIMESTONE DAM ME 00492

PHASE I INSPECTION REPORT NATIONAL DAM INSPECTION PROGRAM

SEPTEMBER 1981

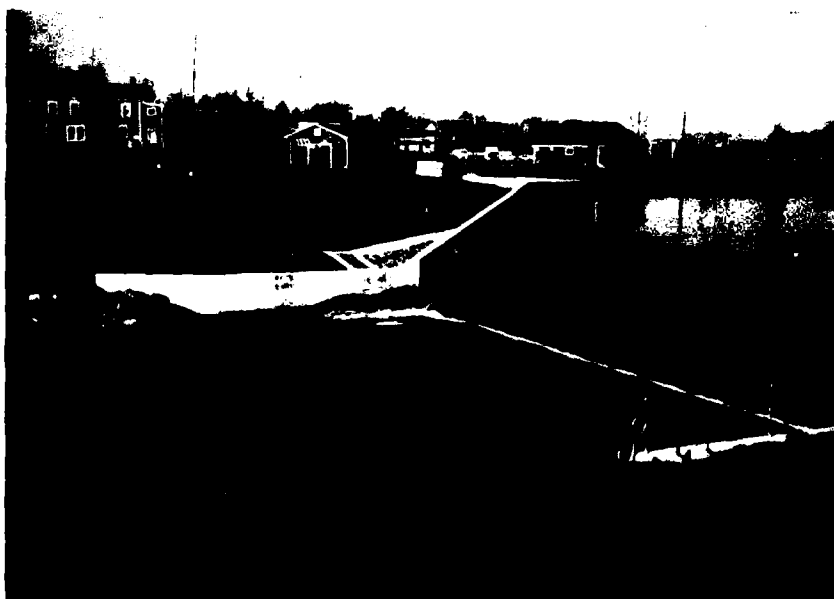
(3) Downstream slopes - The downstream slope rip-rap appeared in good condition. The slopes have well developed, tight grass covers. No significant gully action was observed on the slopes (Photos 5 and 6). No slides or sags were observed.

(1) Spillway - The broad crested weir spillway and chute were in good condition (Photo 5). The adjacent reinforced concrete training walls were also in good shape with no visible deterioration.

PHOTO #5
SPILLWAY WITH FISH
LADDER AND VALVE
SHAFT

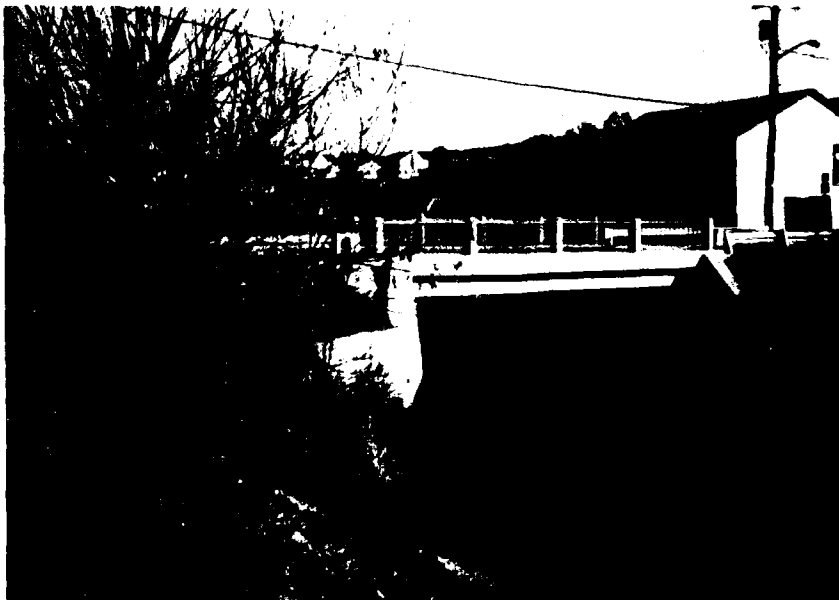
PHOTO #7

VIEW UPSTREAM FROM
